## **Investigation of accident scenarios between pedestrians and city buses in Thailand**

**S. Lakkam\* and S. Koetniyom**

### **ABSTRACT**

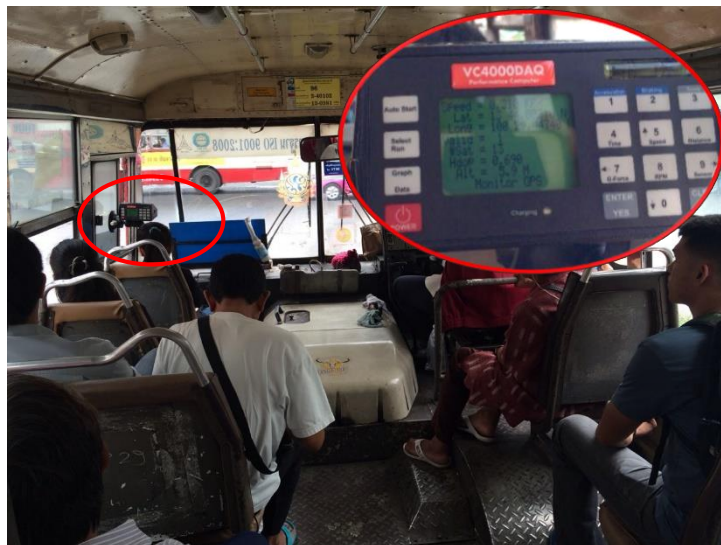
Figure 3. Kinematic measurement of public bus using VC4000.

There are 22 pedestrian-city bus collision cases which have been fundamentally investigated, all of which occurred in Bangkok and suburban areas from January 2012 to July 2013. In all of these cases, the victims were walking or standing when they were struck run-over by the front of a vehicle. These instances excluded the cases of people who had been and the victims who were struck by the side or rear parts of a vehicle. This information is supported by the insurance company and the Bangkok Mass Transit Authority (BMTA) and subsequently, an on-scene examination was performed. At the incident scenes, the identical locations were investigated to estimate the impact speed of the vehicle as shown in Figure 2. Furthermore, the working day, time period and city bus were also estimated. Regarding accident data, pedestrian-city bus collisions were investigated in 19 (86.3%) out of the 22 cases using a kinematic measurement device

called VC4000 (Figure 3), a performance and braking test computer [10] which was used to investigate vehicle speed. So, the acceleration, speed and distance information from the incident place were recorded as shown in Figure 2. However, there were 3 incident cases of 22 cases which occurred in the bus garage where the travel speed is very low. Thus, these cases were omitted for incident reconstruction. By collecting collision scenarios, not only impact speed and deceleration but also speed limit feasibility was measured.

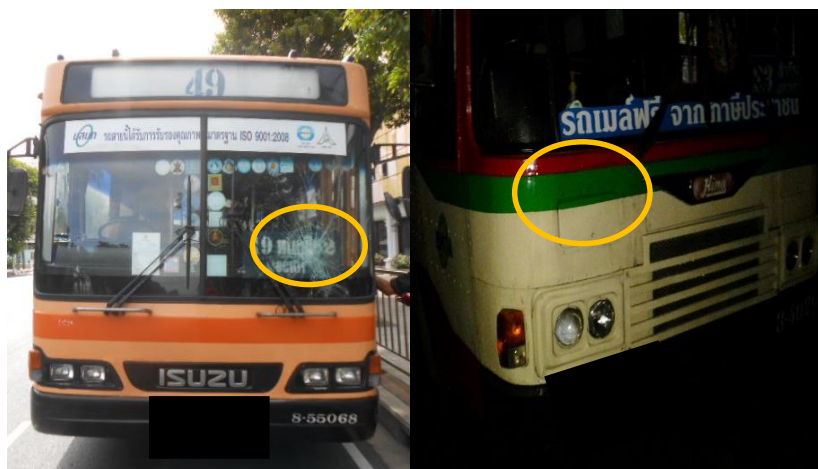
Figure 5. The low- and the high-located windshield city bus collision damage from hitting pedestrians.

Besides, comparison between the low- and the high-located windshield cases with the similar bus speed, as shown in Figure 5, revealed that the low-location windshield city bus collision with a pedestrian caused a critical condition at 22.43 km/hr of impact speed (left side of frontal bus), while the high-located windshield city bus collision with a pedestrian caused a fatality of the victim at 19.22km/hr of impact speed (right side of frontal bus), which was lower. It can be concluded that the location of windshield plays

a major role in the injury mitigation. Furthermore, the concordance between windshield location and average human height of Thai people is shown in Table 5.

Most of the severe head injuries (AIS>3) in both types mainly occurred as a result of contact area between the head and the windshield frame and/or the A-pillar. Regarding the information from the experimental study of bus speed and medical records, fatalities were only found in the high-located windshield type, with the body region injuries (head, chest and abdomen) induced by the front frame. On the another hand, there were no fatalities in case of the low-location windshield type in which there was only one critical victim at the body region injuries (head and abdomen) induced by the windshield and front frame of bus.
